# Lubbock County Project Updates

July 8, 2024

# McMillan Dam

# Horseshoe Bend

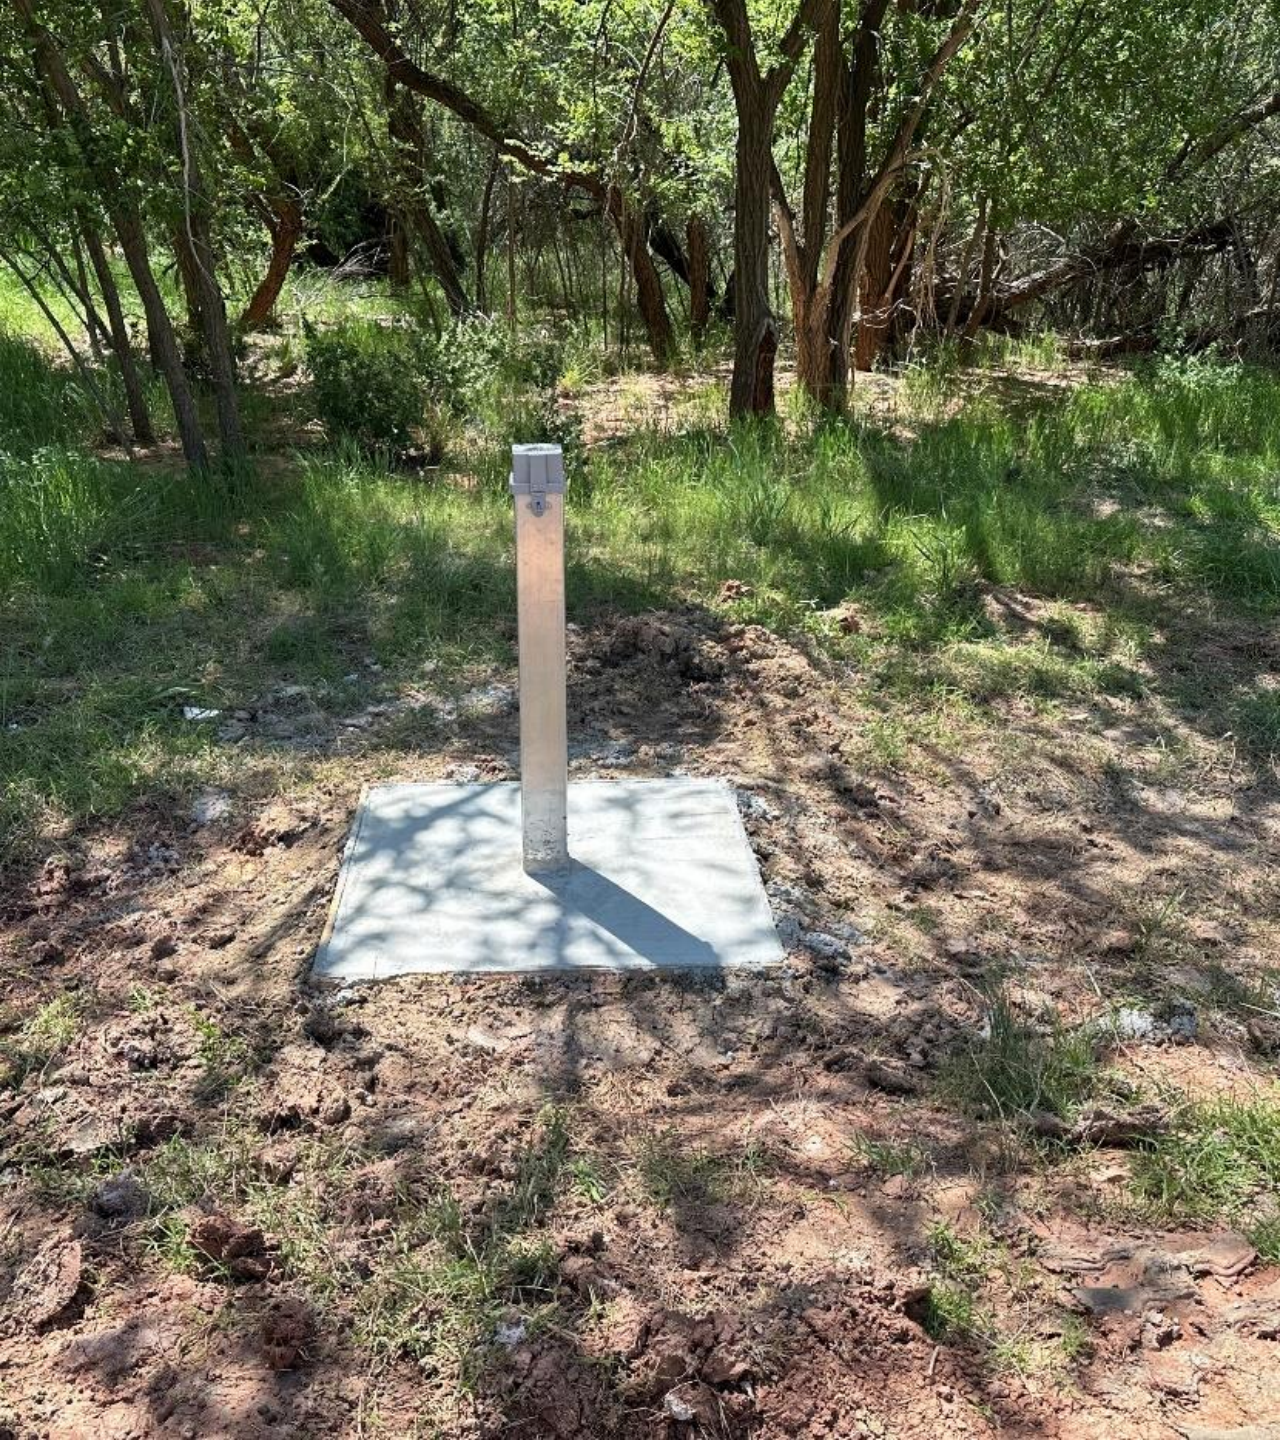
Upright piezometer completion at embankment toe. Used to determine existing phreatic (water) surface through the embankment and head pressure (uplift) at the toe of slope. Data will inform seepage and slope stability analysis during design.

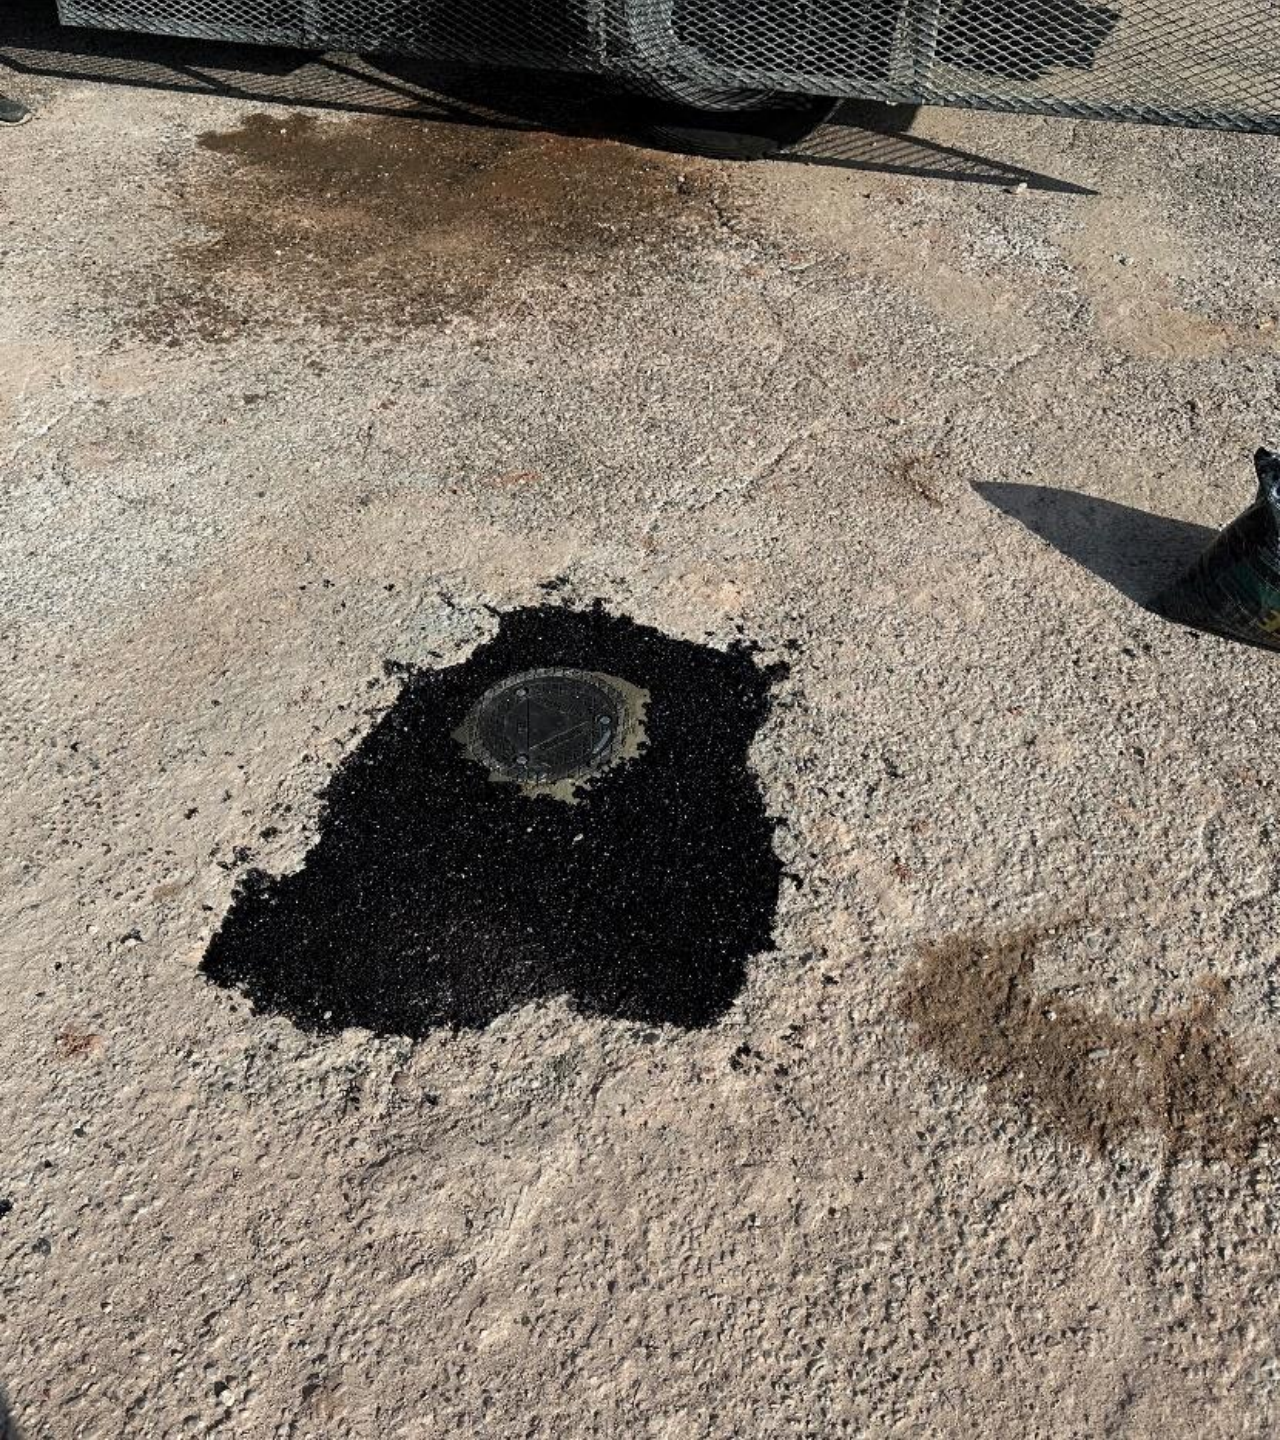
Piezometer surface completion on embankment crest. Used to determine existing phreatic (water) surface through the embankment. Can be used long term to monitor water levels through embankment.

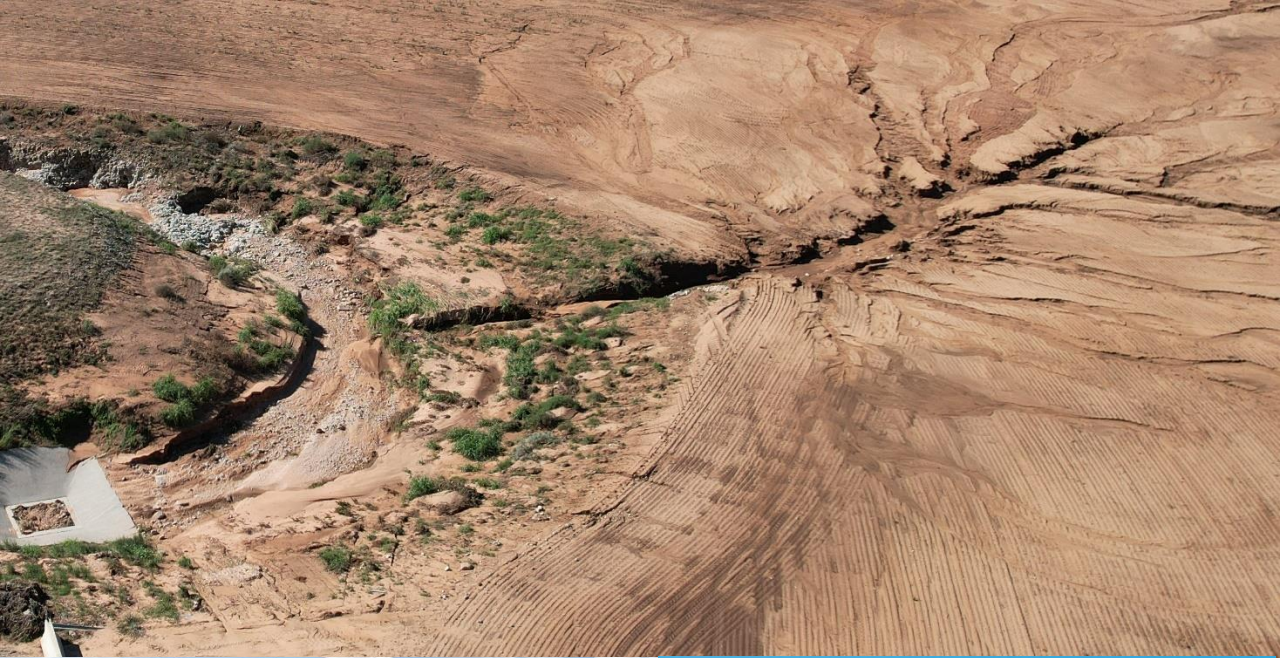
FNI observed that the 7'x 7' inlet was clogged with sediment buildup and debris. There was evidence of ongoing erosion/sedimentation from the upstream field

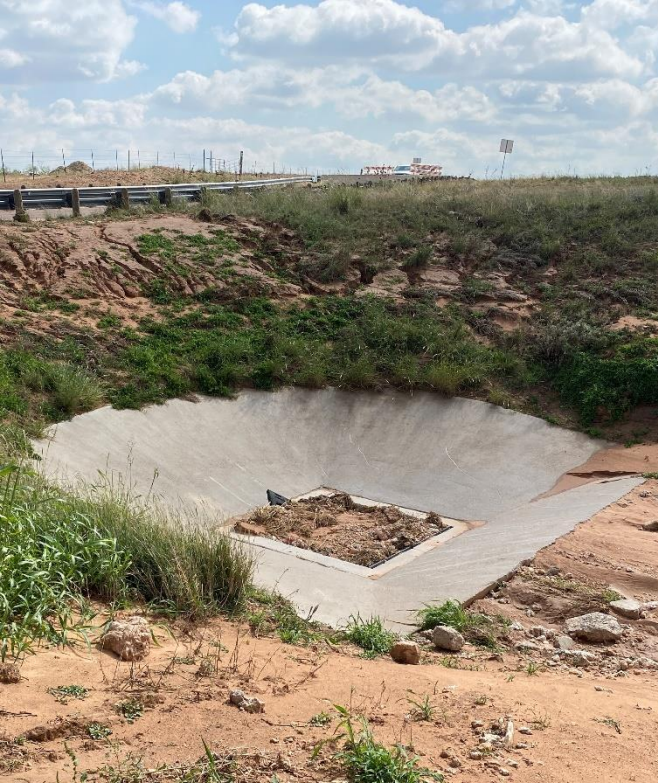
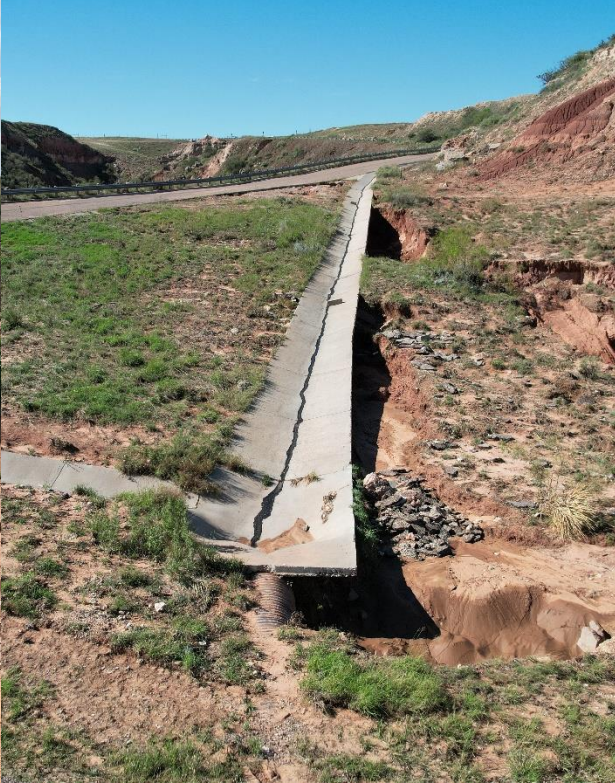
Adjacent to the roadway there was erosion and undermining of the concrete gutters.

On the outlet side (east) of the roadway, an incised gully has formed between the roadway and the west gabion wall of the outfall structure

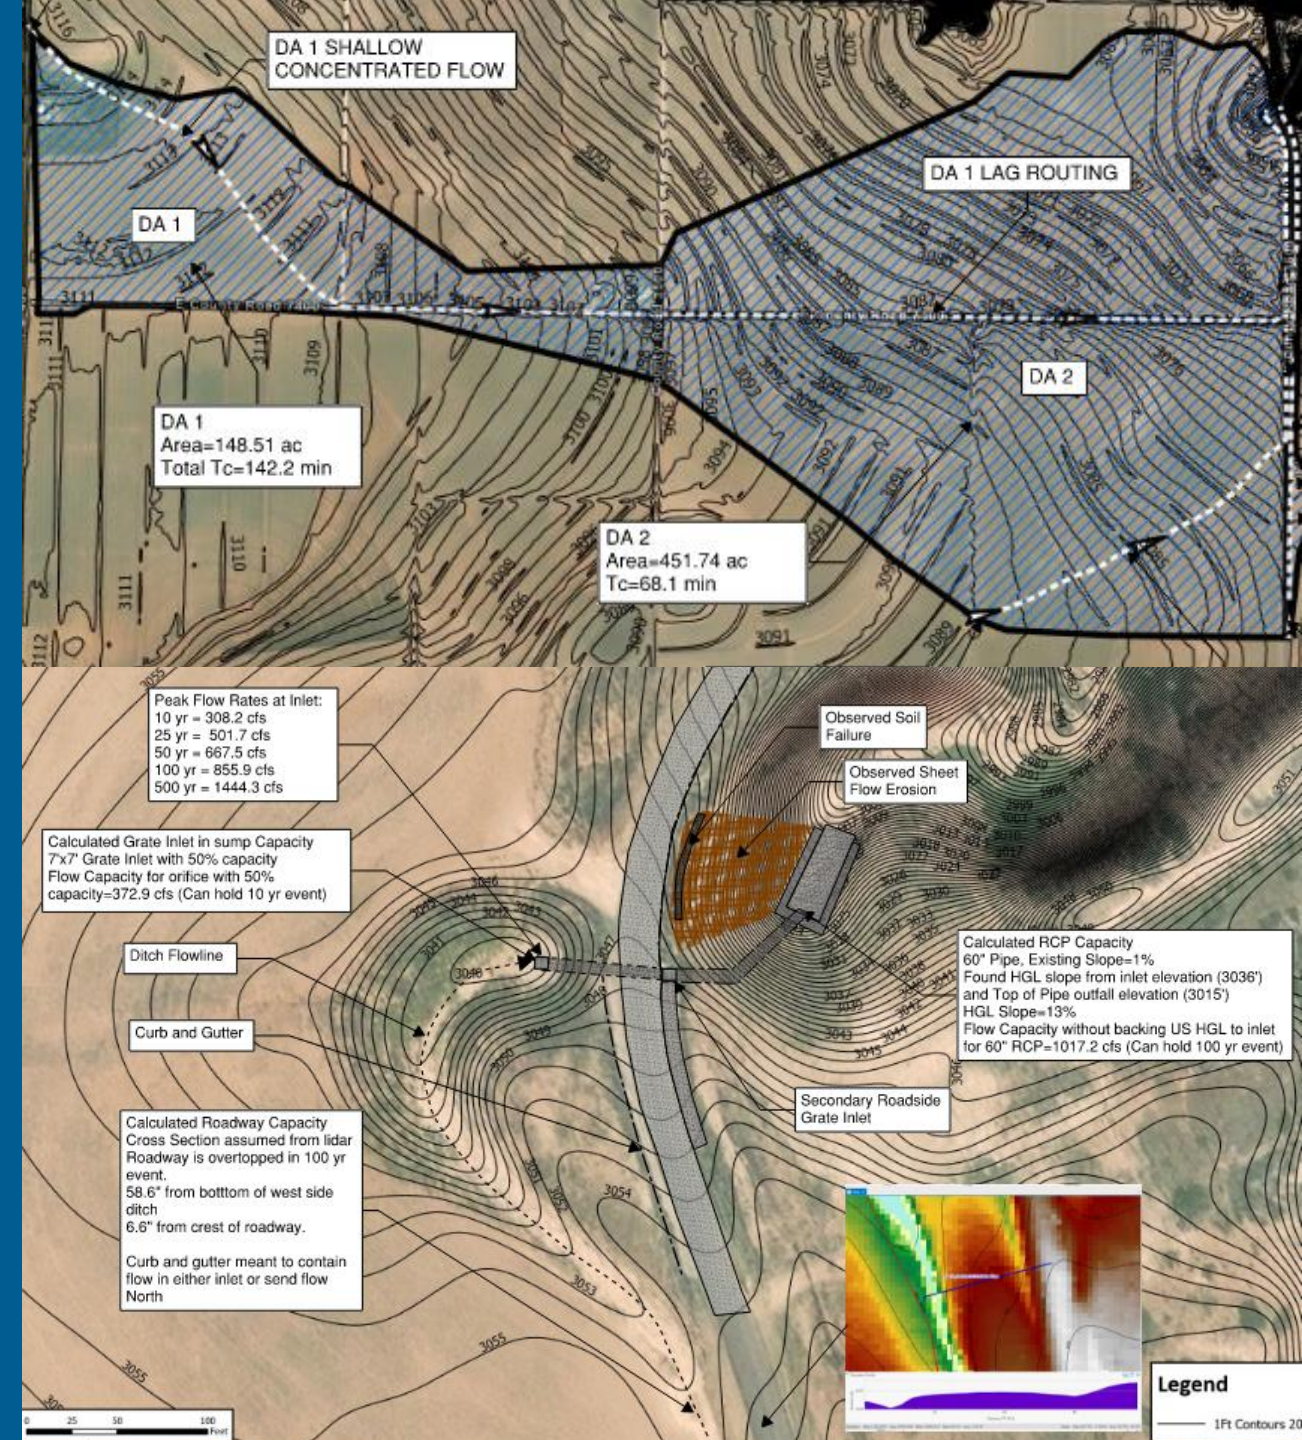
FNI concluded that the existing infrastructure is inlet controlled.

It was determined that the erosion protection at the outfall and downstream of the gabion flume is insufficient for the flows coming out of the pipe.
